Our Ref: 2021.07.09-JHF-Ltr Rpt-All Saints Church, Kempston (Weathervane)

**Ref: All Saints Church, Church End, Kempston, Bedford MK43 8RH – Tower Weathervane**

Following our site visit on 15 June 2021 to inspect the existing weathervane arrangement, we write as promised to outline the findings from our visit, with a view to proposing an alternative support method when the weathervane is replaced,

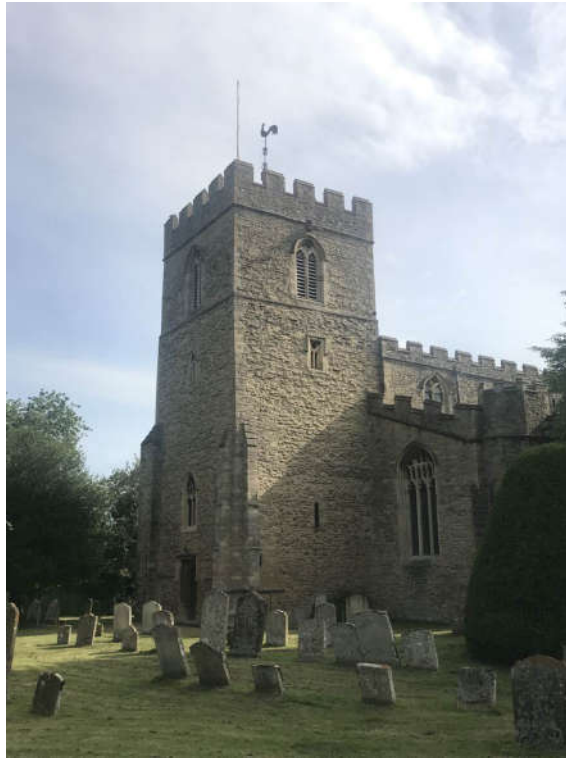
Photograph 1 – South West corner of tower

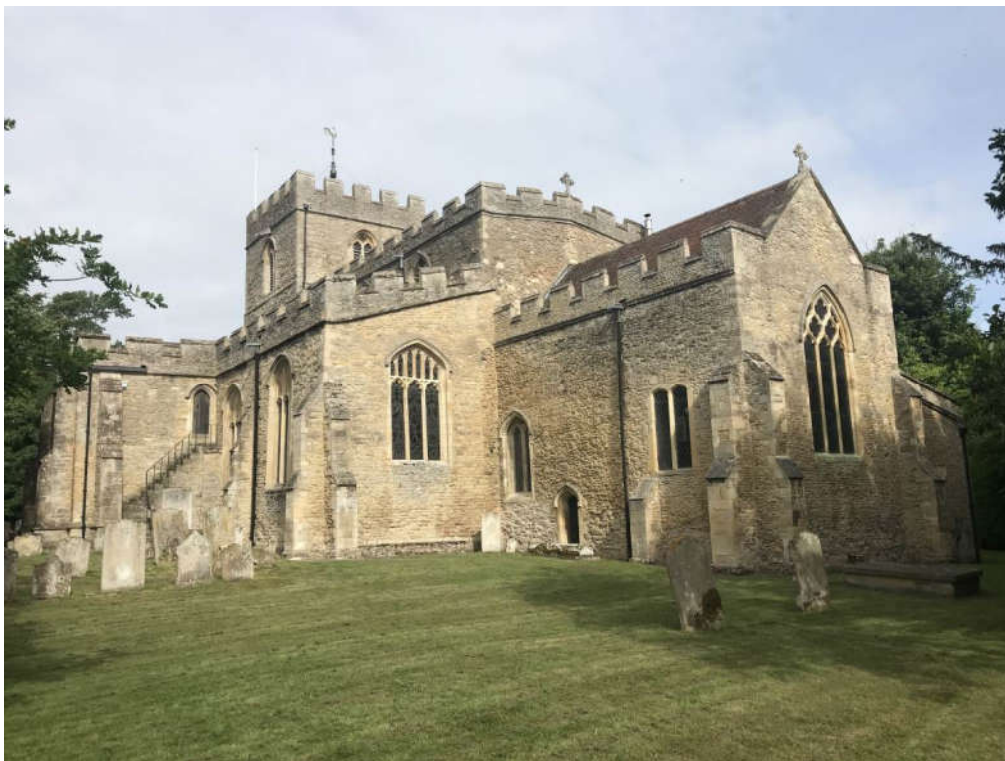
Photograph 2 – South East corner of church

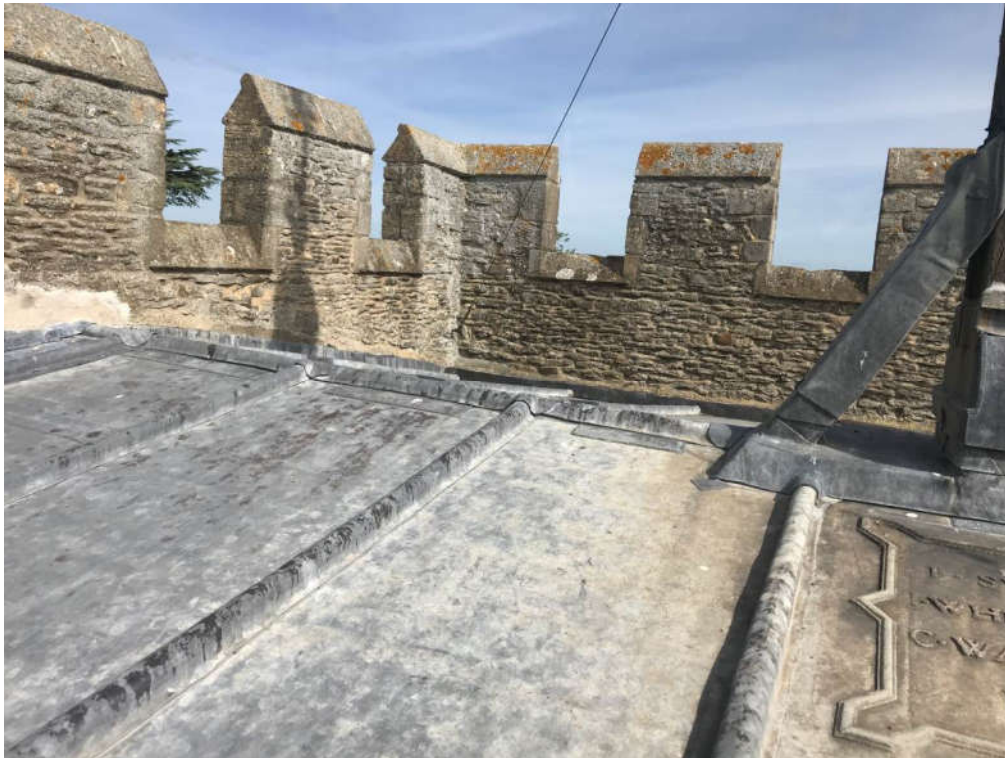
The church has been constructed in traditional stonework (limestone) with stone dressings/quoins. The roof of the Church is generally plain clay tile finished, although the tower has a substantially patched lead sheet finish.

Photograph 3 – Tower roof finished in lead

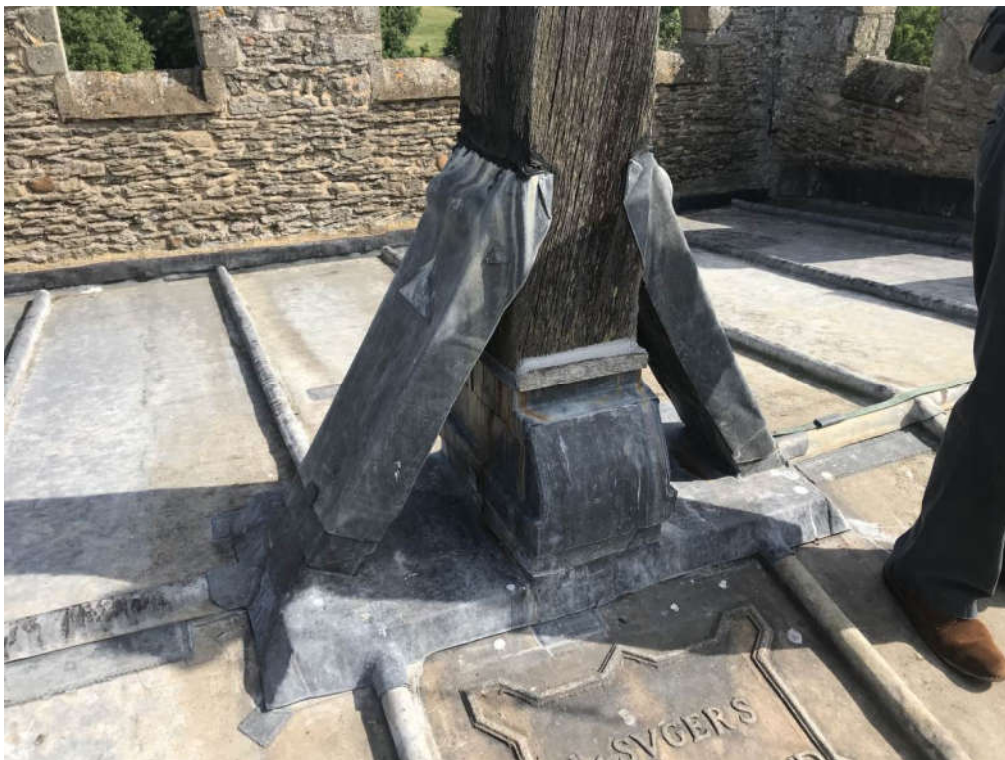
The existing weathervane is centrally located to the tower roof and consists of a timber post approximately 4m high, with 2m high decorative metalwork above. The timber post is laterally restrained in the East and West directions via 0.8m high timber braces at its base and via 4 No. metal cables fixed at its apex and to metal eyes embedded in the stone parapet. The weathervane's support post and braces penetrate the lead roof finishes and due to the poor condition of the timber post and associated poorly detailed flashing detail, it has been noted that rainwater is leaking through the roof finishes at this location in heavy rain. A

number of repairs to the leadwork have been undertaken over the past 10 years, but although the water ingress has reduced, it is still present. This ongoing water ingress is causing the timber post to decay at its base and the metal shims between the ridge beam and its strengthening plates have begun to corrode.

Photograph 4 – Poor leadwork details around existing post

The PCC have suggested that they would like to replace the weathervane and if possible, support it via a steel framework above roof finish level. This will allow the lead roof finishes to be continuous, with no penetrations that could lead to future water ingress. The proposed steelwork will consist of PFC members fixed to the 300mm thick parapet walls, that will in turn support principal beams spanning the full width of the tower. These principal beams will support the new weathervane and braced support post on short perpendicular secondary beams. We have produced a conceptual arrangement sketch (SK001) for the proposed steelwork to allow further discussion. However, until a detailed analysis of the steelwork is undertaken, it is unclear whether the steel beams will be able to span the full width of the roof and avoid clashing with the existing roof ridge. In addition, the proposed steelwork may have a negative effect on the parapet walls, potentially causing cracking in the future due to the stiffening effect of the steelwork and the new proposed loads that will be applied to them.

We have therefore researched into alternatives and would highly recommend using a bespoke flagpole system that is braced at its top with tension cables fixed to the corners of the tower. These systems are commonly used to support weathervanes on church roofs and will be less invasive to the tower structure. The system usually consists of a lightweight aluminium or stainless steel pole braced at its apex to the corners of the tower with stainless steel tension cables and fixed to the roof structure/boards below with a suitably sized metal base plate. The pole and base plate usually arrive in two parts to allow for easier construction and are bolted or screwed together. The roofs lead is laid over the base plate and dressed up the pole. A skirt will be prewelded to the pole for the lead to be dressed under and prevent water ingress. This solution will be more lightweight, easier to construct and should be a cheaper option for the church. Sketch SK002 shows this option.

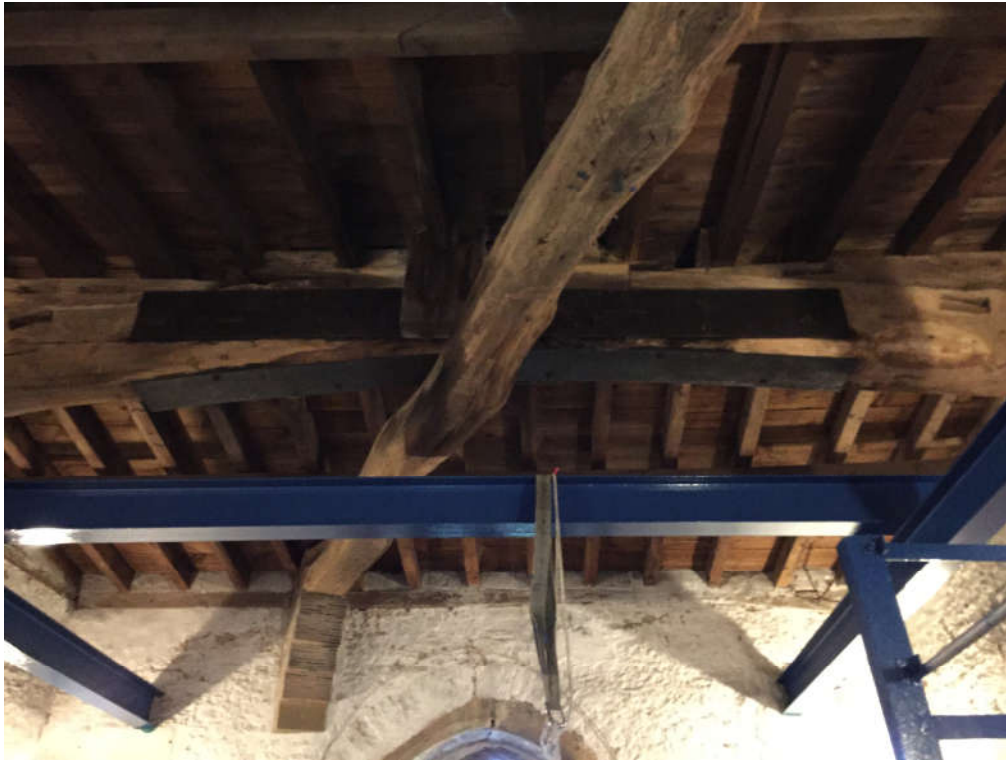
The existing shallowly pitched roof structure consists of timber common rafters spanning between a centrally located ridge beam (spanning East to West) and the North and South external stone walls, with purlins at mid-span. The ridge beam has previously been strengthened with steel metal plates fixed to each side and the bottom face of the beam. This ridge beam is also supported at mid-span via another timber beam spanning between the North and South external walls at a slightly off perpendicular angle. This beam is supported on a clay tile and cement mortar corbel construction bedded into the external walls.

Photograph 5 – Principal support beam supporting strengthened ridge beam

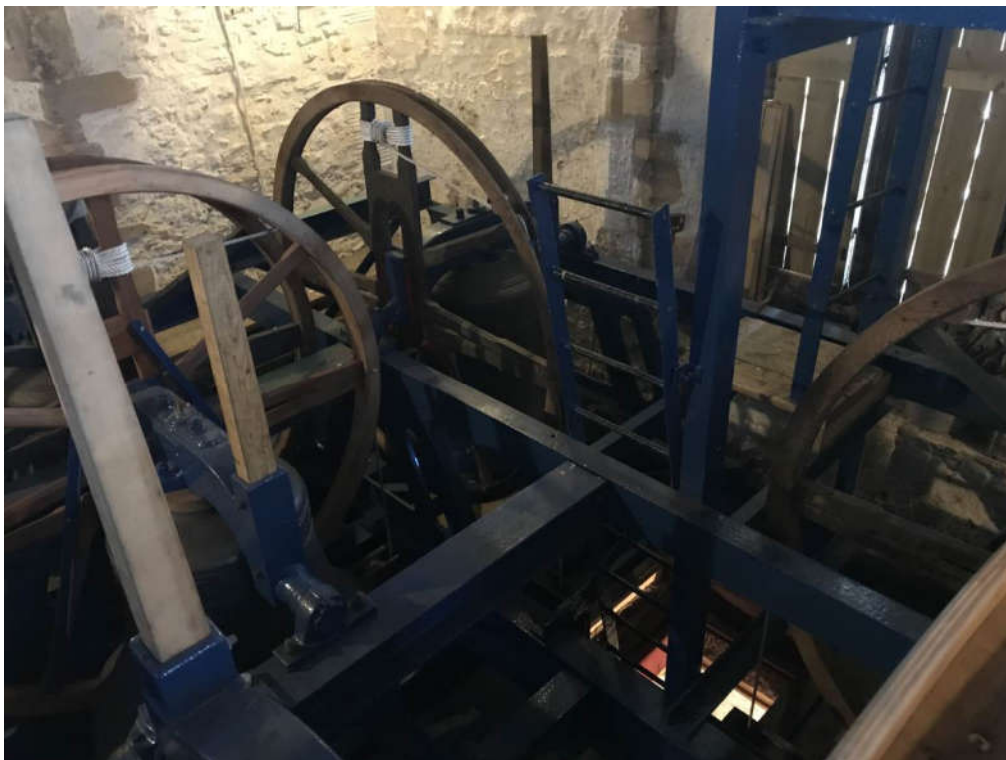
The 1970's bell frame is formed in structural steelwork and a photograph of the general arrangement is included in the appendix of this report. However, the Belfry Floor and First Floor structures all appeared to be formed traditionally with suspended timber beams supporting timber common joists. Although the new steelwork is essentially tying/stiffening the tower in two directions, generally there is limited cracking within the tower visible internally despite the new steel frame being supported on concrete padstones cast into the external walls. Whilst we understand that the bells are rung on a regular basis, the walls at first floor and belfry level are not cracked and we would, therefore, suggest that there has been limited movement related to the use of the bells internally. That said, the significant vibration that the use of the bells will deliver, may disturb some of the loose external cementitious pointing at parapet level.

Photograph 6 – 'Modern' steelwork to support bells

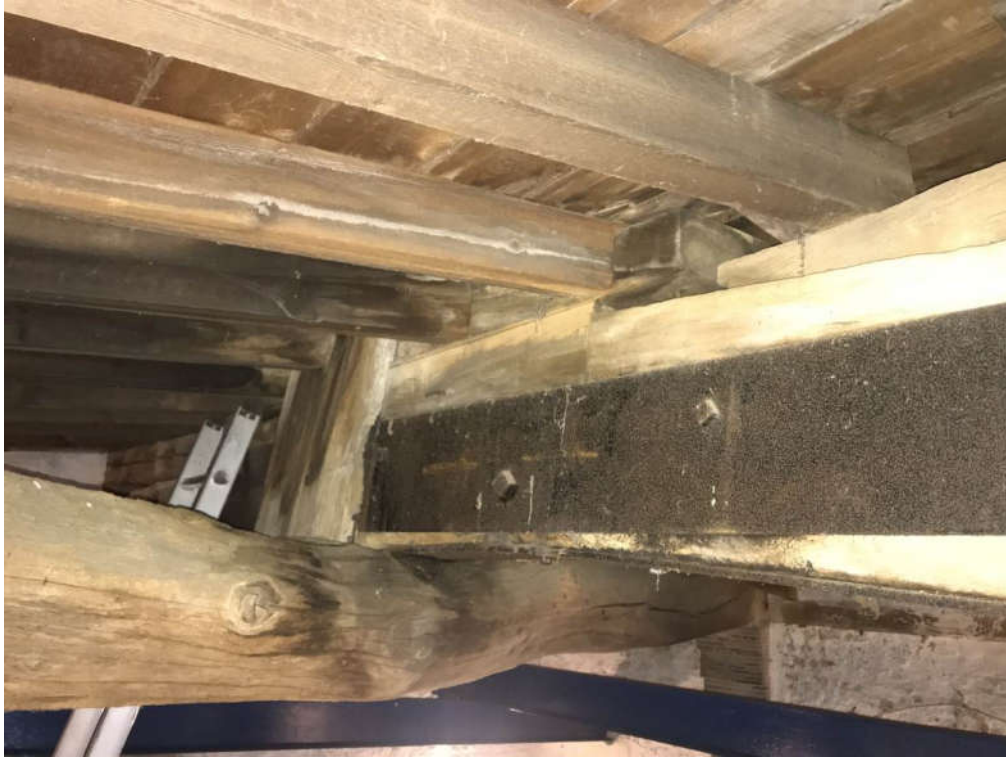
Photograph 7 – Weathervane post fixed to side of ridge beam

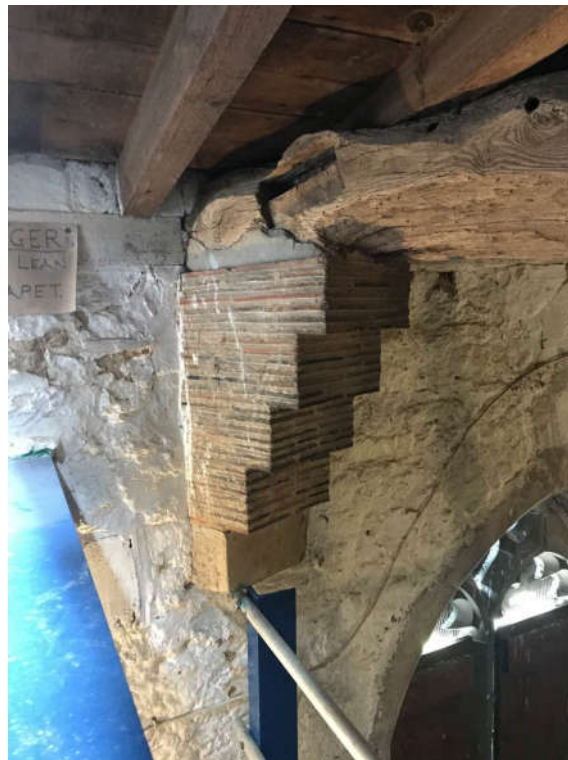
Photograph 8 – Principal support beam bearing on corbelled tile construction

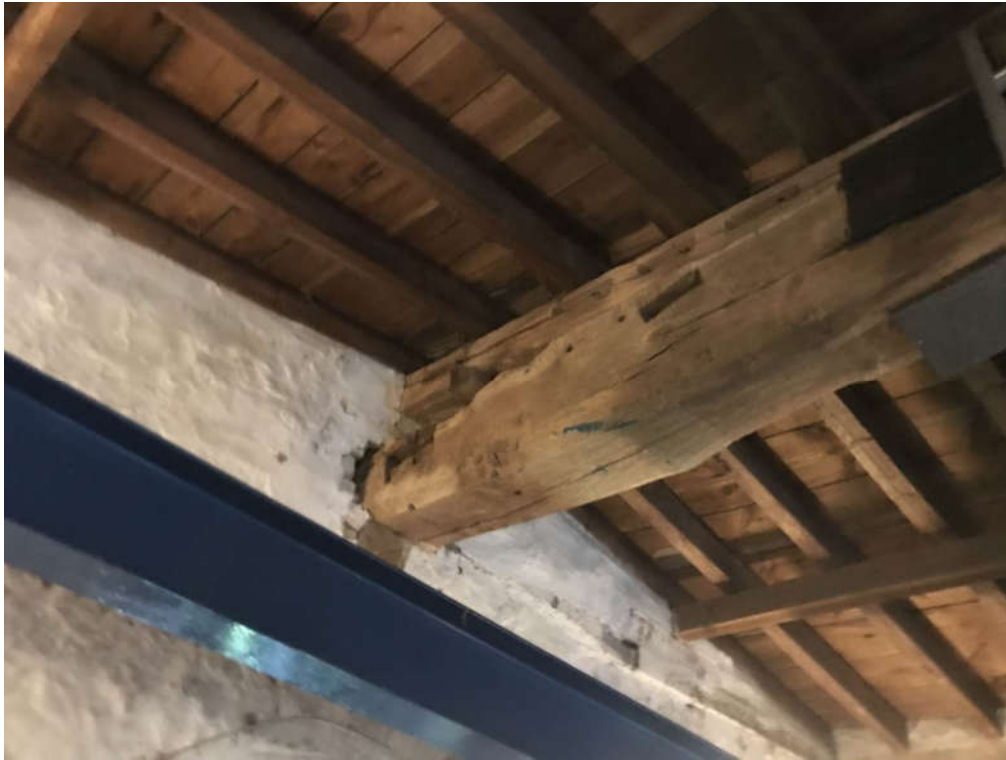
Photograph 9 – Ridge beam support

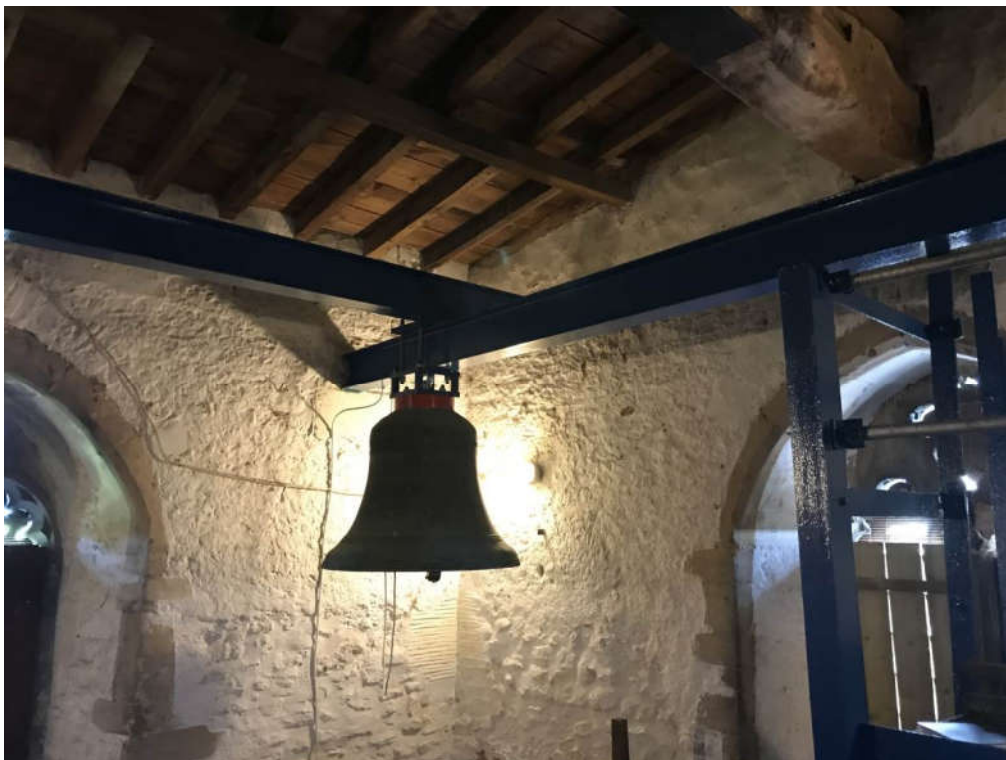
Photograph 10 – 'Modern' steelwork supporting bells

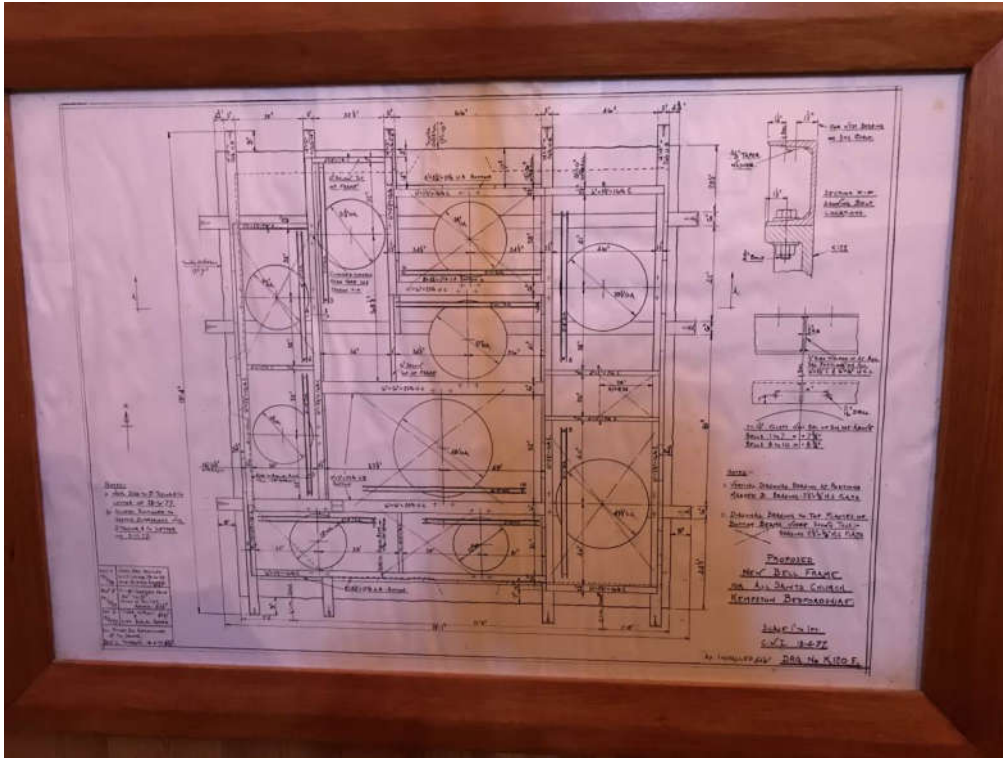
Photograph 11 – Plan of ‘modern’ steelwork proposal (1978)

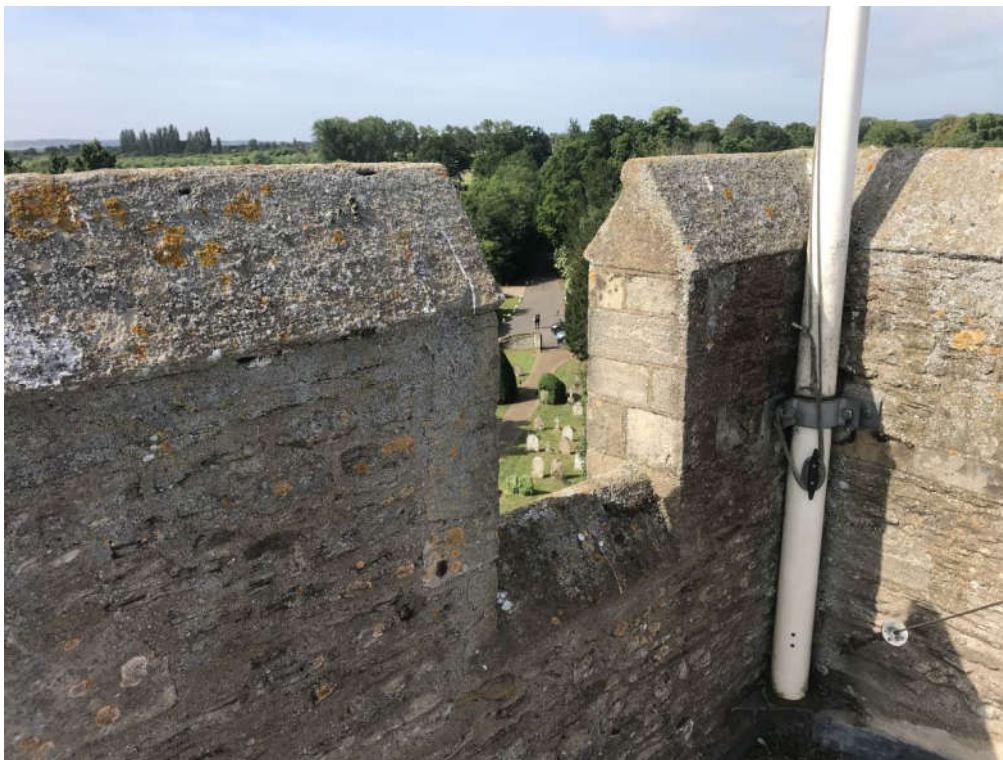
Photograph 12 – Flagpole fixed to parapet wall
