| <p>9.00</p> | <p><b><u>PROTECTION &amp; BATS</u></b></p> | |

| <b>12.00</b> | <b>PHASE REMOVE EXISTING WEATHERVANE</b> | <b>1</b> <p>The existing flagpole is to remain. The Flagpole is currently fixed to the parapet wall. See image below.</p> |

| <b>13.00</b> | <b>PHASE 2 NEW WEATHERVANE</b> | <p>The main contractor should have sent the weathervane specialist the existing weathervane cock and ball/and gold onion finial and rod, scrolls, poles, rods and fixings etc without damaging it.</p> <p>It will be the specialist weathervane manufacturer's preference that the existing copper and iron cockerel and finial, ball and scroll can be restored or replaced and the rod or pole replaced with stainless steel.</p> <p>The original has iron struts which can be replaced with brass if necessary.</p> <p>Rod Fendor<br/>Black Forge Art, Owley Farm, Wittersham, Kent TN30 7HJ<br/>Tel: 01797 270073<br/>Email: <a href="mailto:info@blackforge.co.uk">info@blackforge.co.uk</a></p> <p>To restore or supply and fit a new like for like weathervane, (cock and ball with scrolls, centre ss rod to structure, sphere and supports through the roof structure, to be maintenance free and on a self-lubricating bron

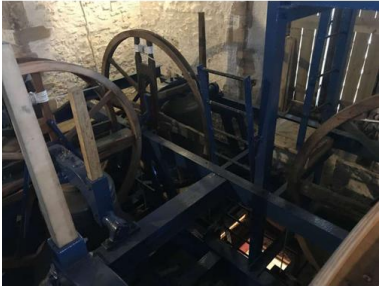
| <p>9.01</p> | <p>PROTECTION</p> | <p><b>OUTSIDE</b><br/>Fully protect the church from the repair work.</p> <p>Provide barriers to enclose the work to comply with Health and Safety Regulations allowing for continued use of the church on a Sunday for worship and all other days needed.</p> <p>Allow to supply and erect 1.8m high security fencing around the working area and to the compound area. Ensure the security fencing is securely fixed and padlocked together.</p> <p>Access to the tower roof is very difficult. The main contractor is to ensure all health and safety measures are included in the tender allowing for harness points and temporary handrails etc as necessary to comply with CDM 2015</p> <p>Materials and equipment can be bought up over the organ loft balcony, and then via the ringing chamber and bell chamber. The fabric must be fully protected.</p> <p>Some equipment and materials can also be hoisted from over the side of the tower directly to the tower roof, but full protection of the fabric must be provided.</p> <p>Allow for the supply and maintenance of tarpaulins and adequate weather sheeting to protect the church and works from inclement weather and properly weigh down tarpaulins to prevent wind lift.</p> <p>Fully protect the roof from fire from hot welding leadwork. A hot works permit will be needed. Provide extinguishers.</p> <p>Remove fencing, protection and sheeting at the end of the contract.</p> <p><b>INSIDE</b><br/>There were ten bells in iron frame. Two old bells of 1603 and 1633 which are relatively thin.</p> |

| | | <p>Contact Mr Stephen Stanford on 07742 871724 or Richard Hillson on 07714 533675, to ensure the Bellringers will ring down the bells.</p> <p>Ensure the bells are not to be rung during the works and are hung safely. Fully protect the church bells and belfry inside including the belfry floor. Provide plastic sheeting to cover the bells from dust and damage caused by the work.</p> <p>It is not recommended to open the trap doors up to the bell chamber as access is limited by the tenor bell that sits over the central trap, but this could be done if really necessary.</p> <p>It is very important to cover the bells / bell frame to prevent debris falling onto them.</p> <p>Allow to remove all protection on completion of the work.</p> |

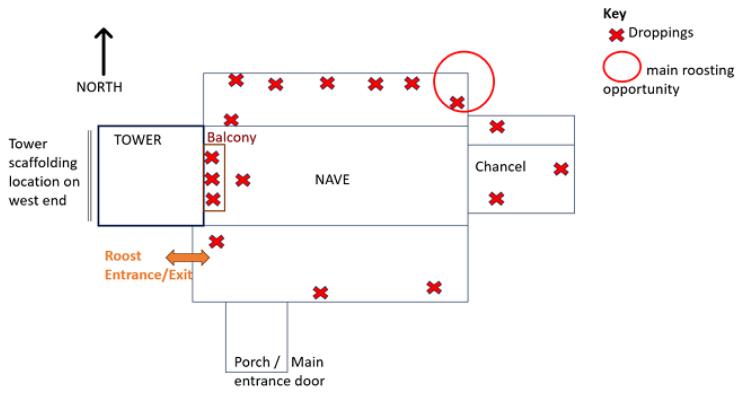
| | | <p>01223 422 116<br/>info@appliedecology.co.uk</p> <p>The main contractor is to contact Dr Duncan Painter, to ensure he is happy with the programme of work and is able to attend visits.</p> <p>Figure 1 Plan and annotation provided by volunteer Carla showing bat droppings location, potential roost location and bat access location.</p> <p><b>Procedure for all works</b><br/><u>Autumn monitoring</u></p> <ul style="list-style-type: none"> <li>• Sweep up old droppings and look for fresh droppings beneath the access and below the roost to monitor the site for roosting bats.</li> <li>• Observe the access point(s) for bats emerging at dusk.</li> <li>• After three evenings of good weather (i.e. no heavy rain or high winds, and a temperature above 7°C) where no bats or fresh droppings have been seen, proceed with the works.</li> <li>• Inform all contractors that there is a bat roost at the property and ensure that they read this letter and understand it. Please explain that while this letter gives the most likely locations and timings for the bat roost, bats may be present in any area of a building at any time of year.</li> <li>• Make a copy of this letter available on site at all times.</li> <li>• Before work commences, all accessible areas that will be affected by it must be checked for bats. Places to search particularly carefully include the areas around the ridge beam, behind gaps in the felt, at the gable apex and under the eaves.</li> </ul> <p><u>Scaffolding.</u><br/>Please note that the above timings include installation and dismantling of scaffolding.</p> <ul style="list-style-type: none"> <li>• Gaps which are larger than 8mm by 20mm, where the back of the gap cannot be seen, may give access/be used by roosting bats.</li> <li>• Bat access at the west facing window, in south aisle, must</li> </ul> |

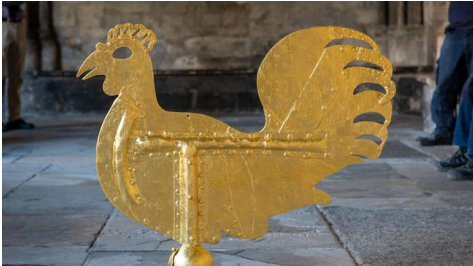
| | | <p>Allow for fitting with the main contractor and support from our structural engineer.</p> <p>Allow to use stainless steel to the central pole, through or onto the roof beam (to be agreed with the structural engineer) including all the decorative sections, scrolls etc to the new weathervane replacement (so giving the ultimate in maintenance-free life expectancy), with a traditional coating finish in black and gold leaf to the cockerel.</p> <p>Allow for an option using 23 carat gold leaf applied to various elements of the weathervane as the existing. Metallic paint is not recommended.</p> <p><b>The main contractor is to allow a PS £500 extra</b> for Black Forge Art to supply and fit 4 new diagonal stainless steel bracing bars and straps secured down and radiating from the 400mm x 400mm square oak post, 1m height (profile to match existing). The main contractor is to allow a <b>PS £1000 extra</b> for the oak post morticed and tenoned and fixed into the ridge beam using ss fixings.</p> <p>(n/a RESTORATION Above: An example of a restored simple three-dimensional weathercock silhouette from Norwich Cathedral. To double prime the existing weathercock and full application of gold leaf would be £1,200 (using double thick exterior gold leaf). If the ball also needs replacing, it would be an additional £500 to have a 365mm diameter spun. total £8,500. Already include in the provisional sum.)</p> |

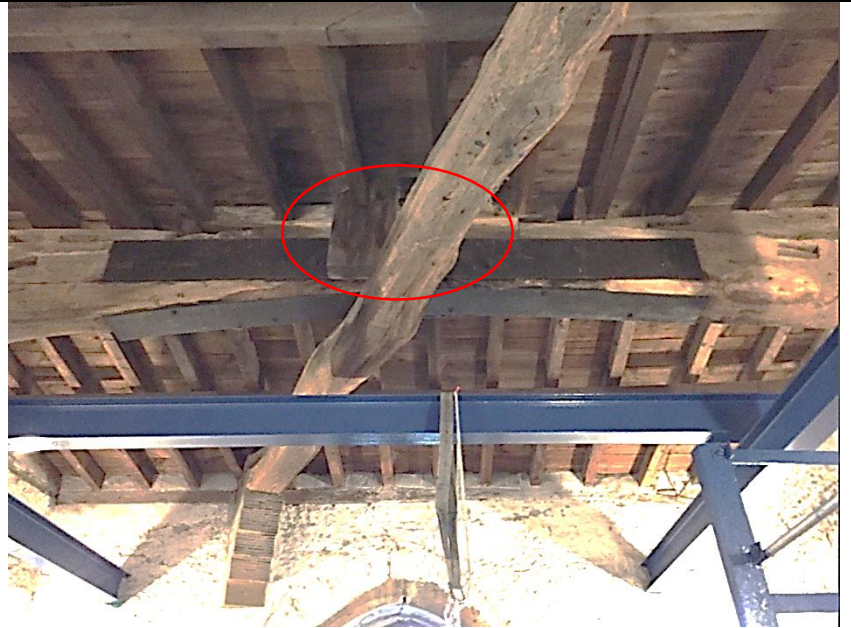
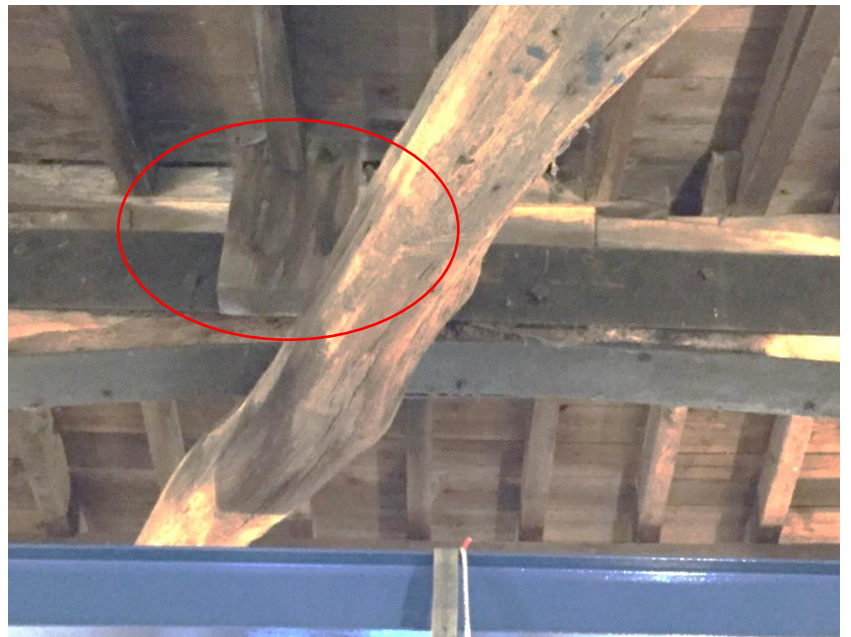
We do not know for certain if the existing iron or steel central pole/ rod may go through the roof and into the beam below, but it does seem likely (typical central pole). The steel reacted with the oak and causes rust and water ingress.
